Addendum to Data Compilation Task Report for the Source Investigation of the 300-FF-1 Operable Unit Phase 1 Remedial Investigations

January 1991

ADDENDUM TO DATA COMPILATION TASK
REPORT FOR THE SOURCE INVESTIGATION
OF THE 300-FF-1 OPERABLE UNIT PHASE 1
REMEDIAL INVESTIGATIONS

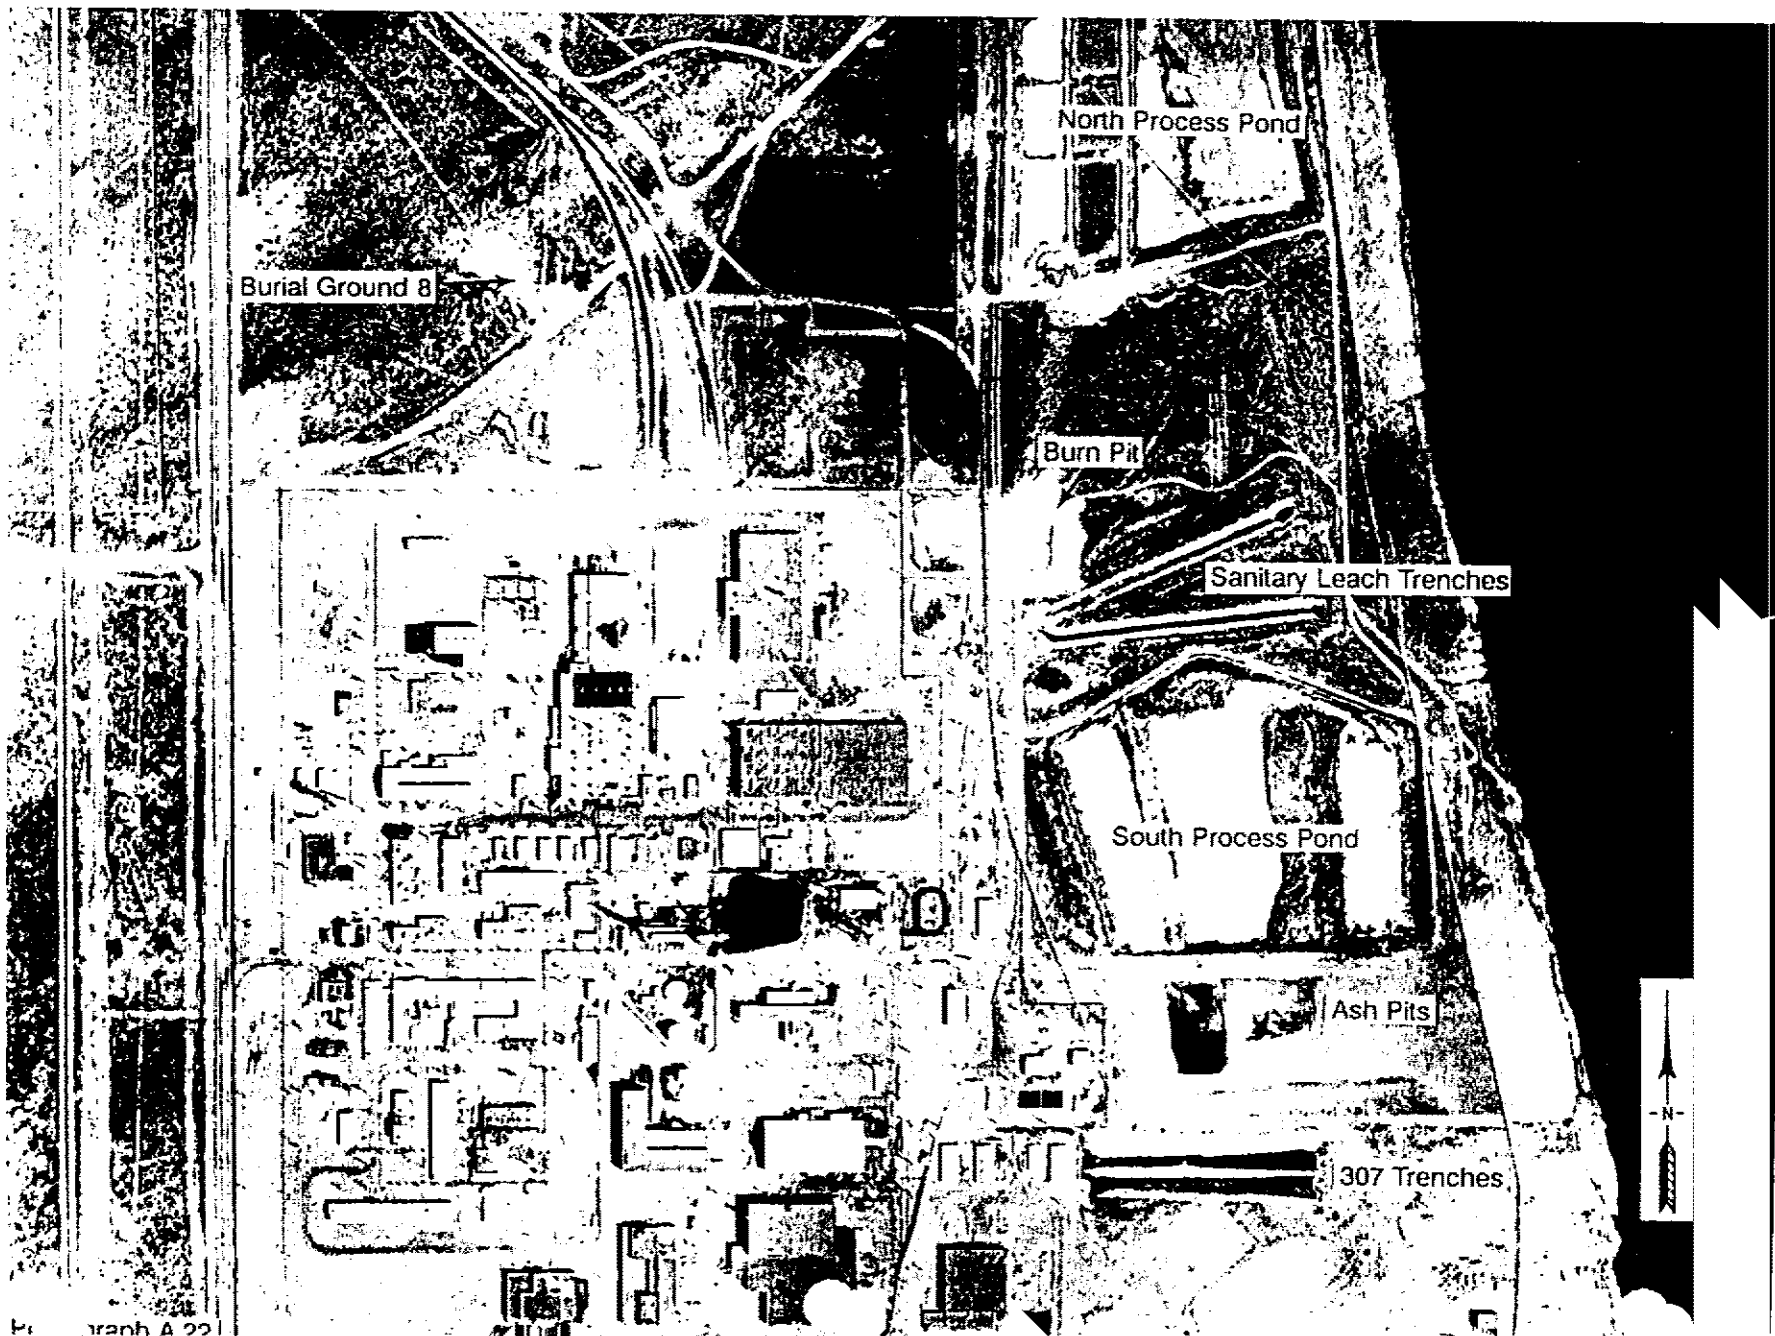
PHOTOGRAPH A.22. June 1962. The North Process Pond has been divided into three additional settling basins. Just north of the septic tank and the Sanitary Leach Trenches is a newly excavated pit for burning debris (Negative No. 29033).

Another pit used for the incineration of debris was dug in 1962, north of the septic tank for the Sanitary Leach Trenches. It can be seen as a newly constructed excavation in Photographs A.22 and A.23. It contained debris in Photographs A.25 and A.27. This pit was used as an alternate burning ground in conjunction with burning in Burial Ground 5. The pits were used alternately to allow them to cool between burnings. Some incidental radioactive materials may have been burned here, but the pit was mainly for paper, wood, paint cans, and other operations debris. In Photograph A.28, taken in May 1974, the pit has been decommissioned and filled.

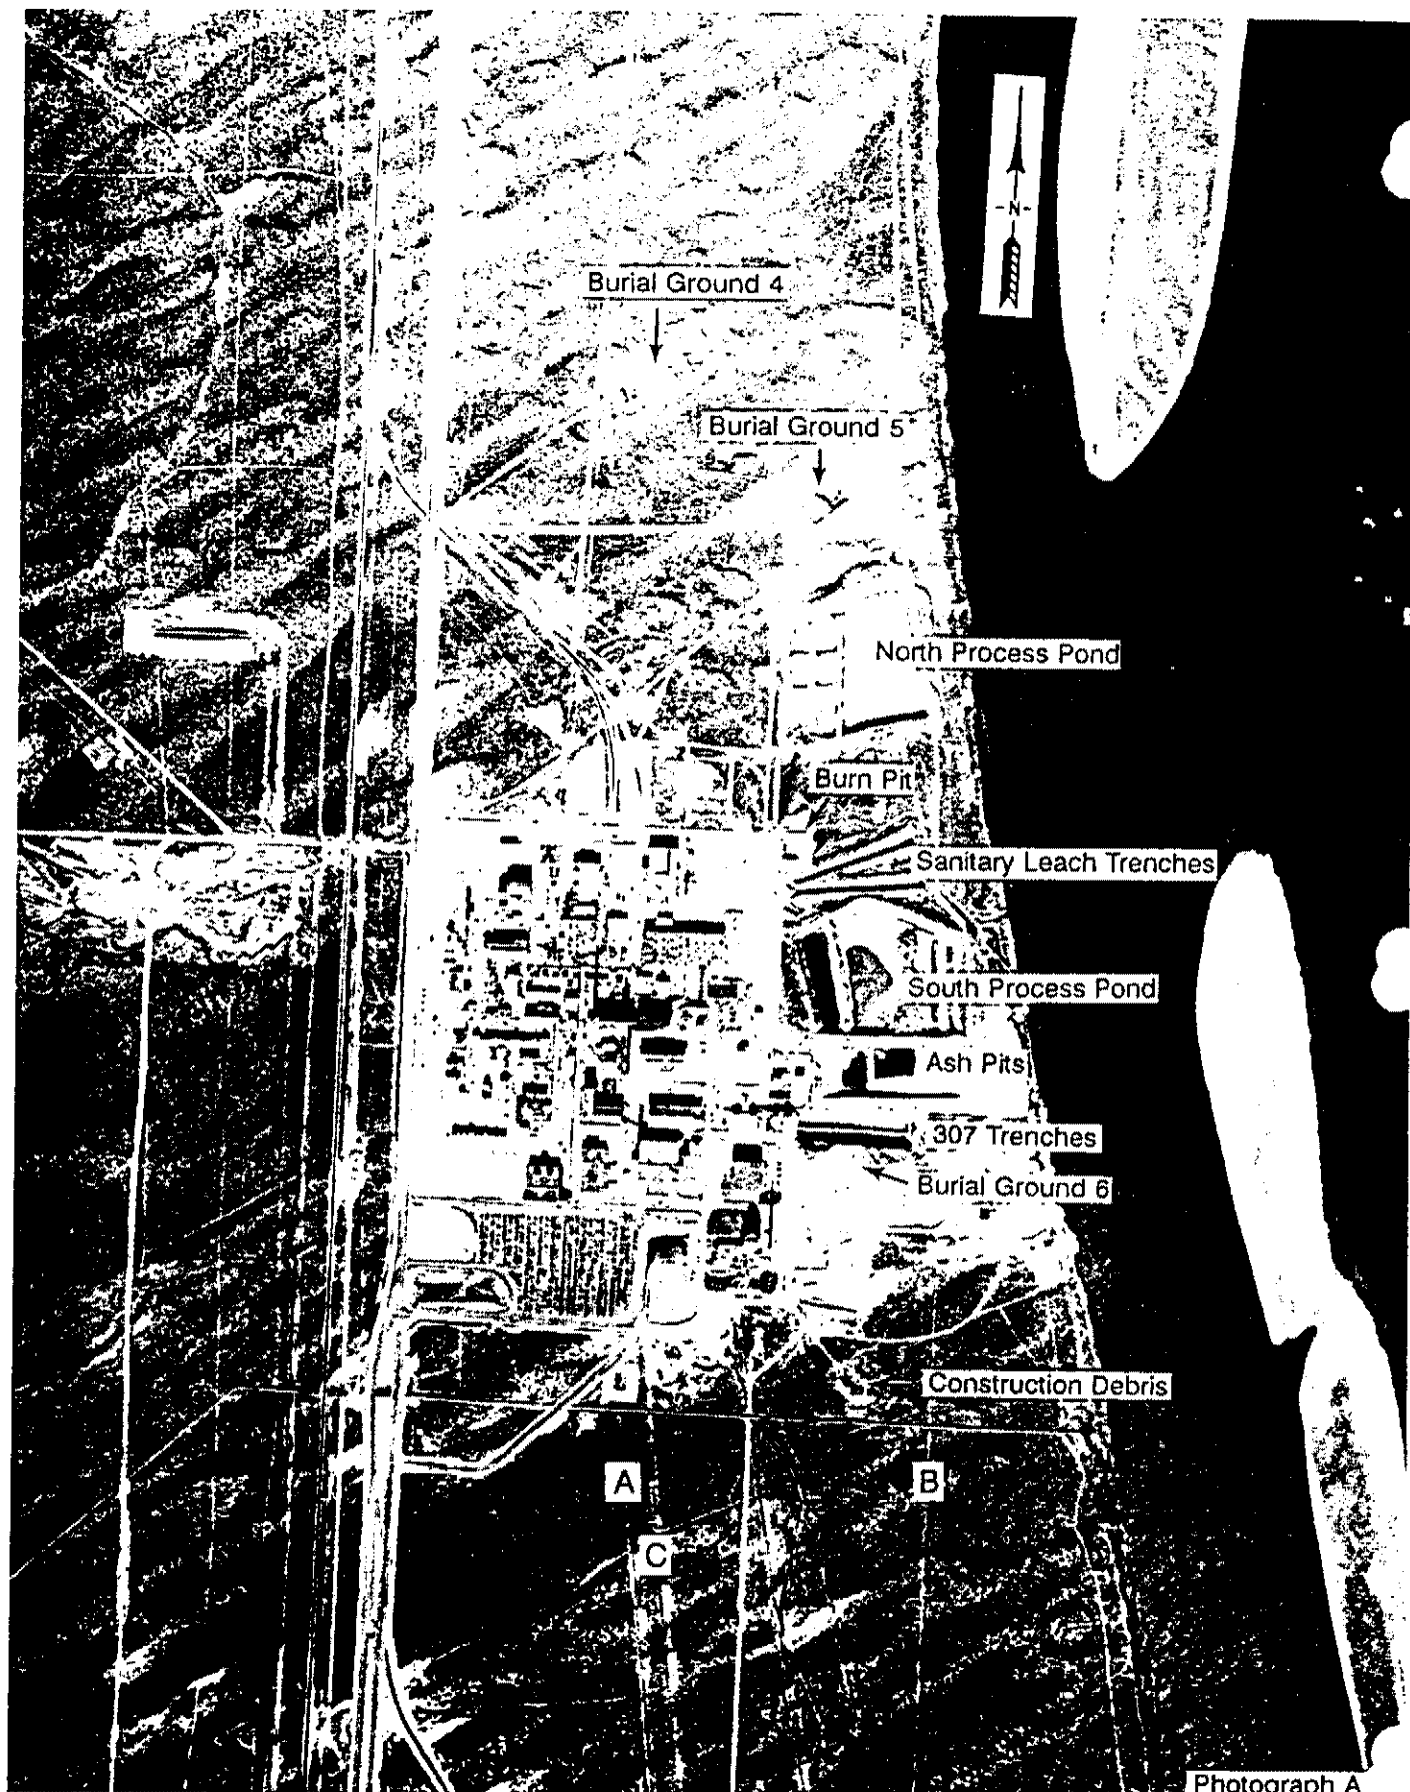
Photograph A

PHOTOGRAPH A.23. 1962. This photograph shows many of the 300 Area waste sites active in 1962, including the 307 trenches, the Sanitary Leach Trenches, the ash pits, the process ponds, Burial Grounds 4 and 5, the 309 construction waste pit, the new burn pit, and burial grounds west of the 300 Area. Prior to the 1970s, fresh water was supplied to the 300 Area from the city of Richland. On the left side of the photograph are three ground scars from the water pipelines. The scar marked "A" is from an early 6-inch line, at one time called the "civil defense line." The scar marked "B" is from a 12- to 14-inch line, and "C" is from a 16-inch line. After the PRTR was placed in layaway, the Filtered Water Plant (315 Building), which supplied the PRTR with water from the Columbia River, became the pumping station for freshwater for the 300 Area (Negative No. 9619).

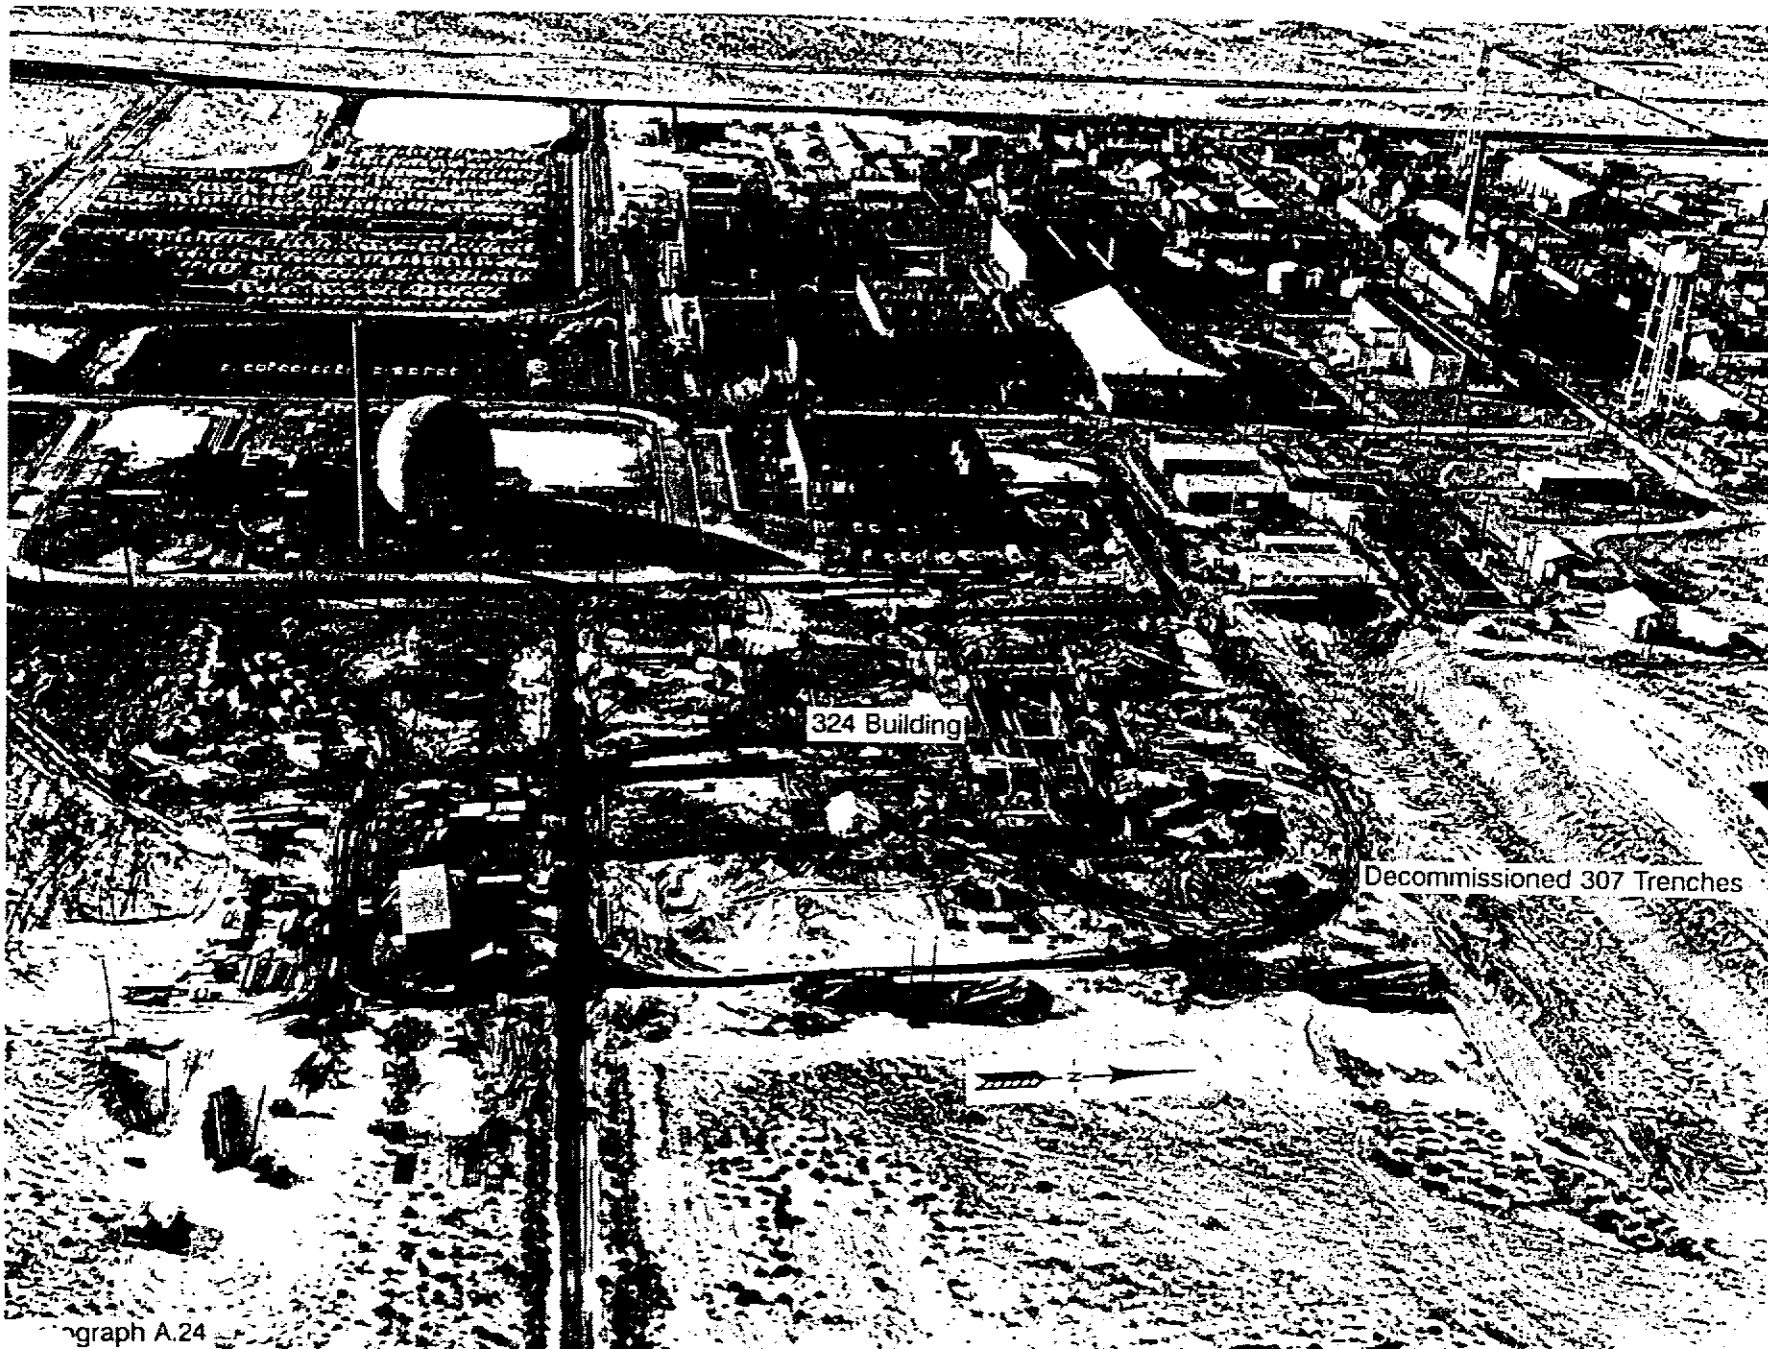
Graph A.24

PHOTOGRAPH A.24. December 1963. The depression in the right of the photograph is the 307 Trenches after they were decommissioned and excavated. The new construction in this photograph is the 324 Building (Negative No. 34631-3).

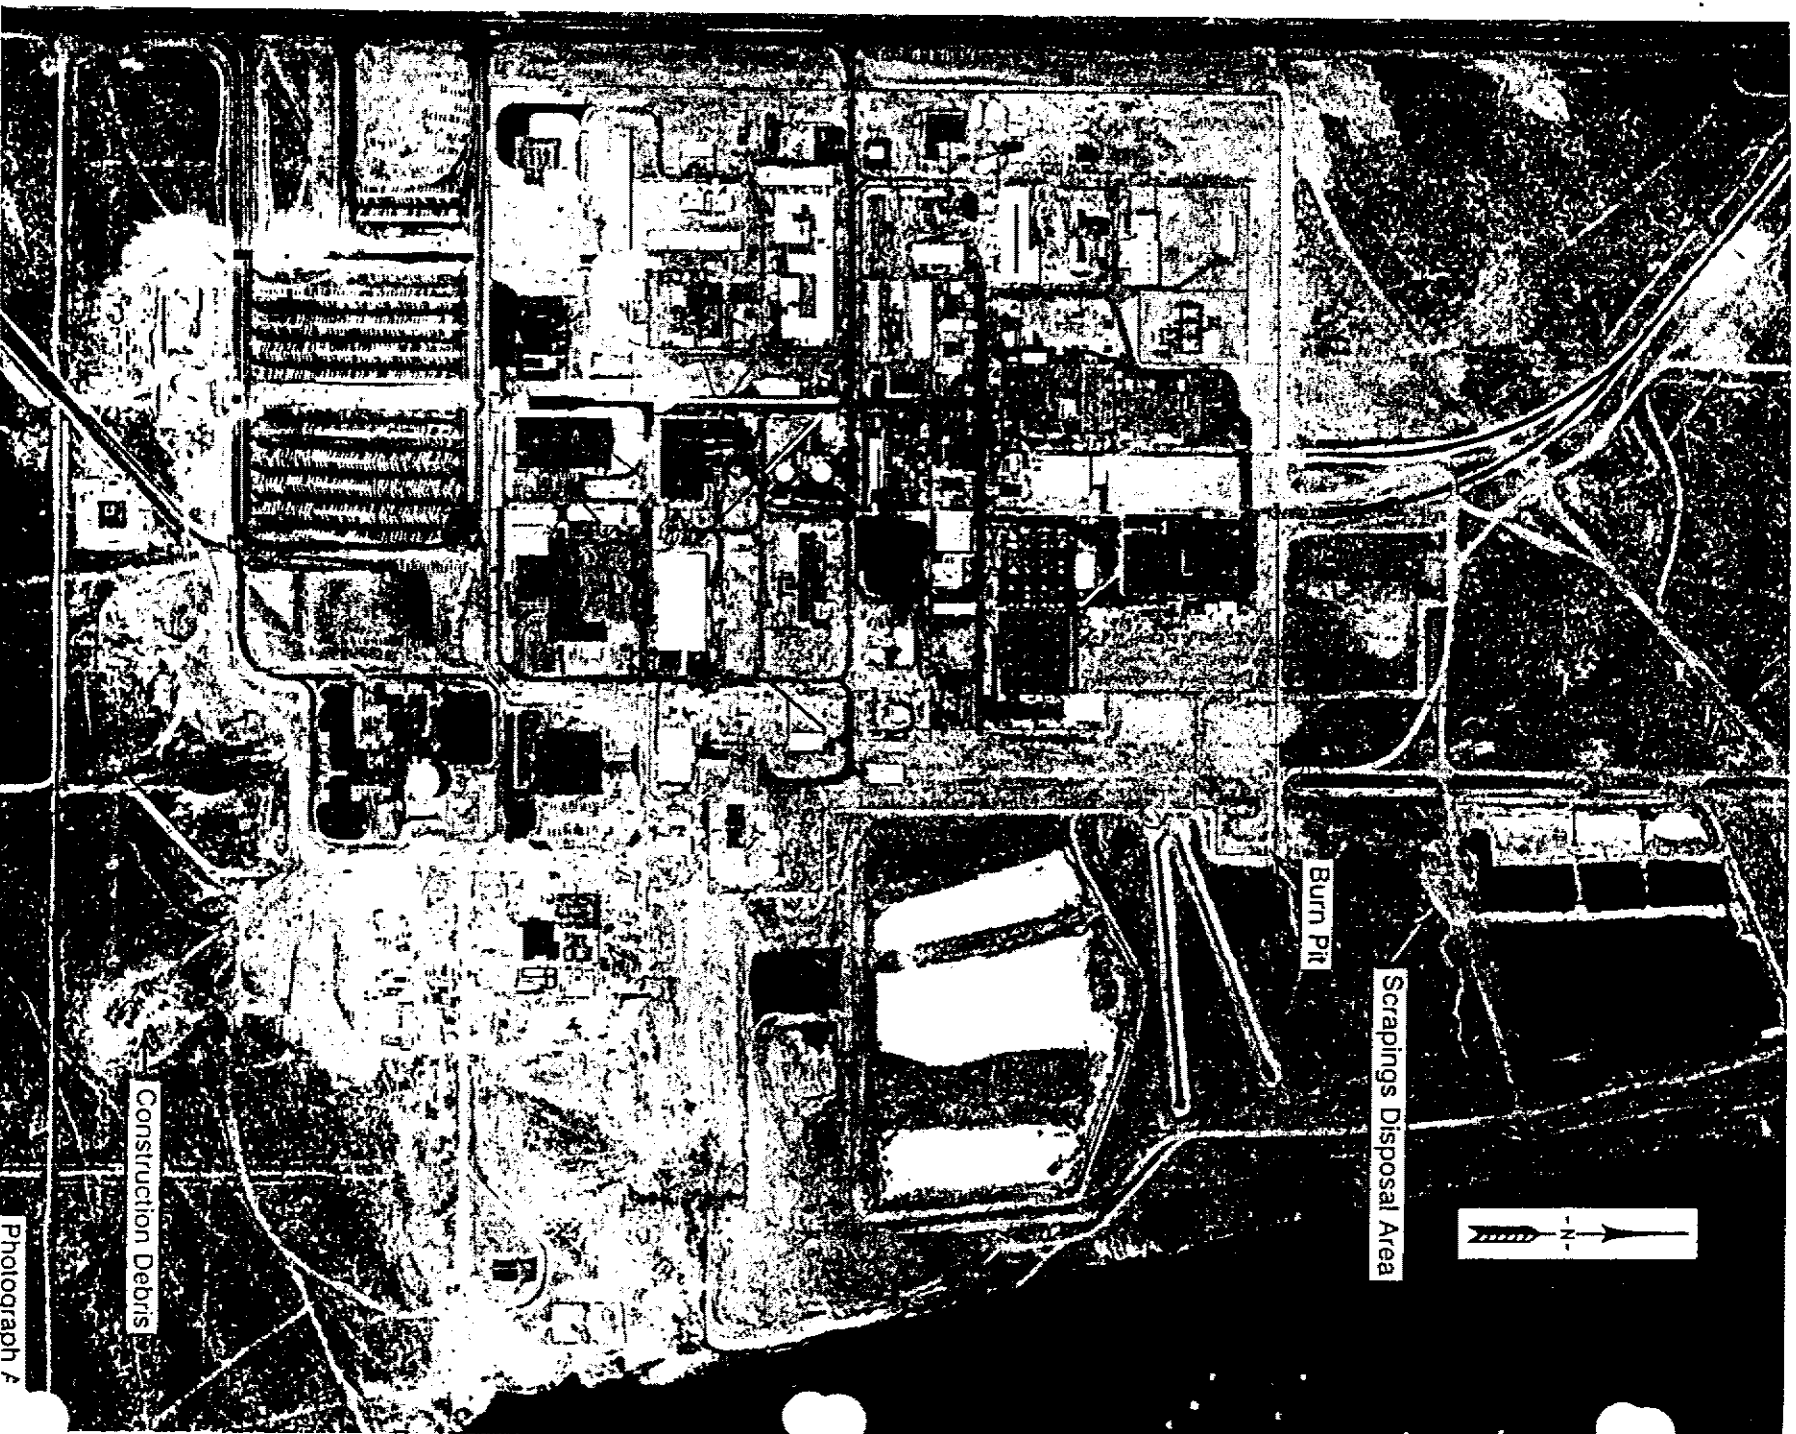
A.5.1

PHOTOGRAPH A.25. 1964. The 307 Trenches are gone, but the 309/PRTR burial pit and the burn pit north of the septic tank still exist. Scrapings from the process ponds can be seen in the scrapings disposal area on the south side of 316-2 (Negative No. 90061562.3).

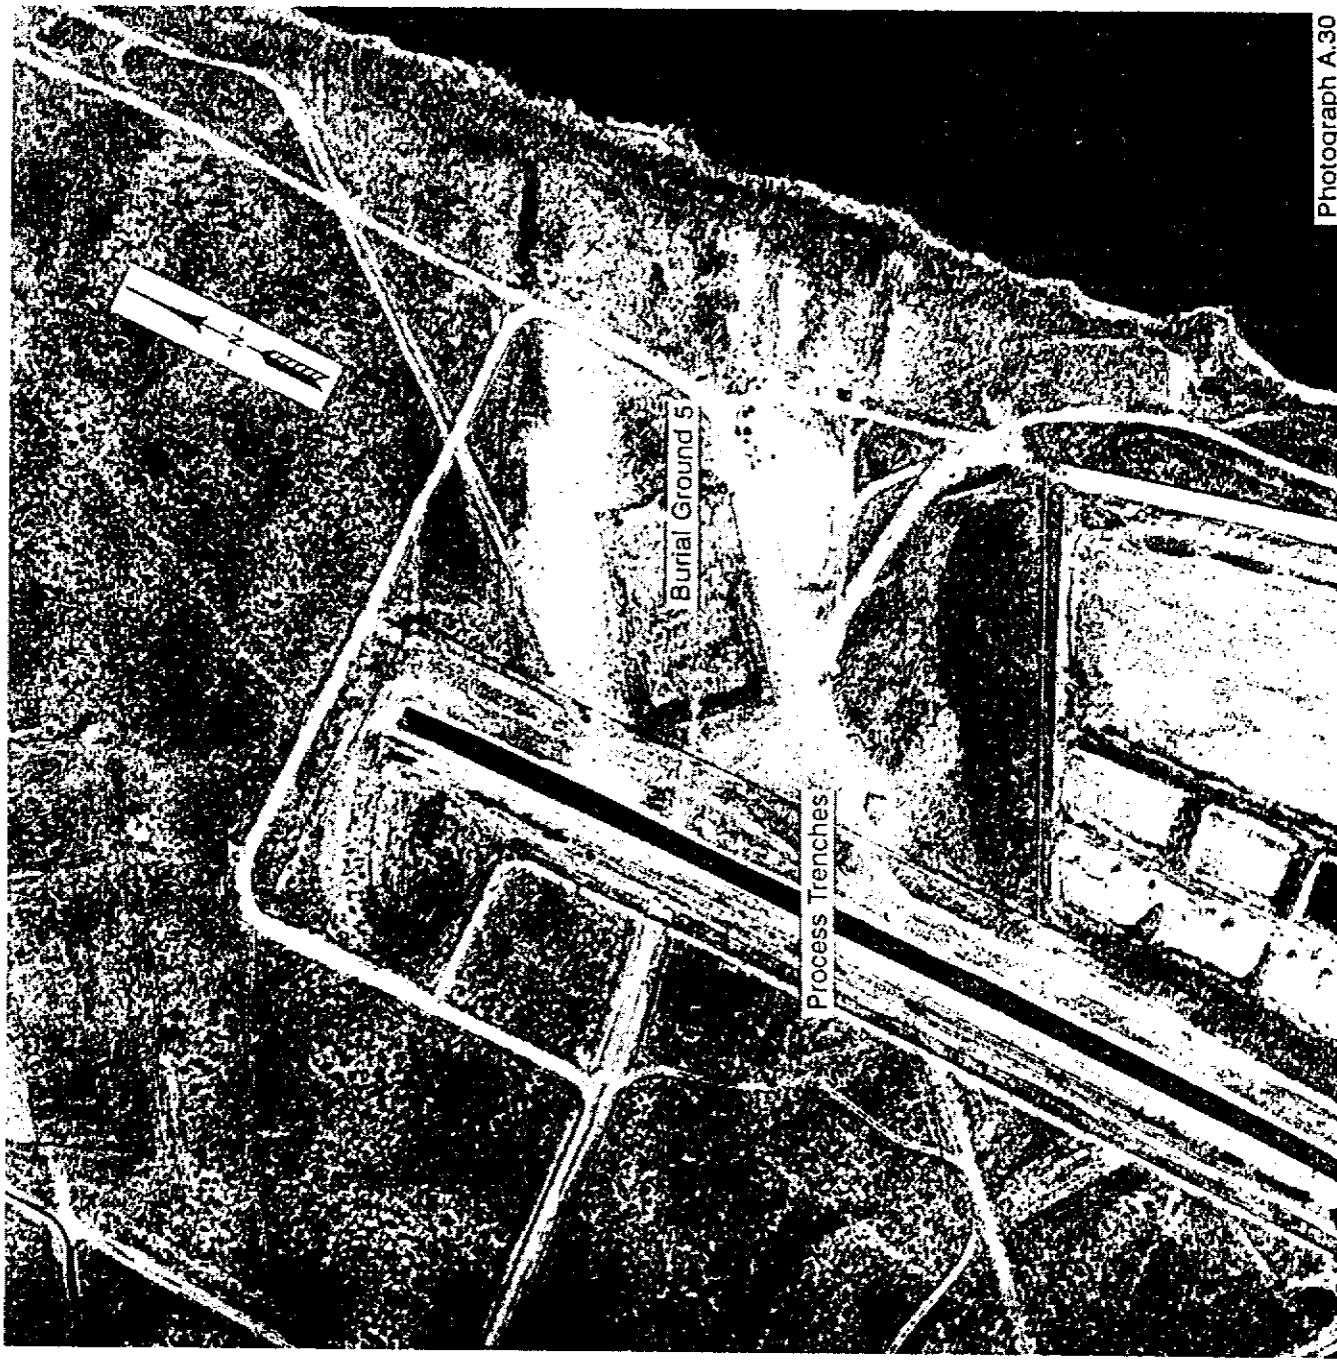
Photograph A.30

PHOTOGRAPH A.30. March 23, 1978. Burial Ground 5 is in the center of the photograph. The site was surveyed with a metal detector, and the white lines indicate areas where metal objects are buried. One of the Process Trenches is full of liquid waste (Negative No. 7803021-4).

Burial Ground 5 (618-5) was used for the incineration and burial of uranium-contaminated (dose rate <1 mrad/h) and nonradioactive trash collected from the 300 Area (see Photograph A.30). Part of its contents include 17 crucibles contaminated with aluminum-silicon or lead having activity levels <200 mrad/h (Phillips et al. 1980). According to Paas (1955), the pit was covered with about 1 ft of soil on August 28, 1953, and posted as a radiation zone. However, Stenner et al. (1988) report that the site was used as a burial and burning ground until 1962, finally being covered with 4 ft of clean soil. A plume of smoke can be seen coming from the site in Photograph A.7, taken January 30, 1952.

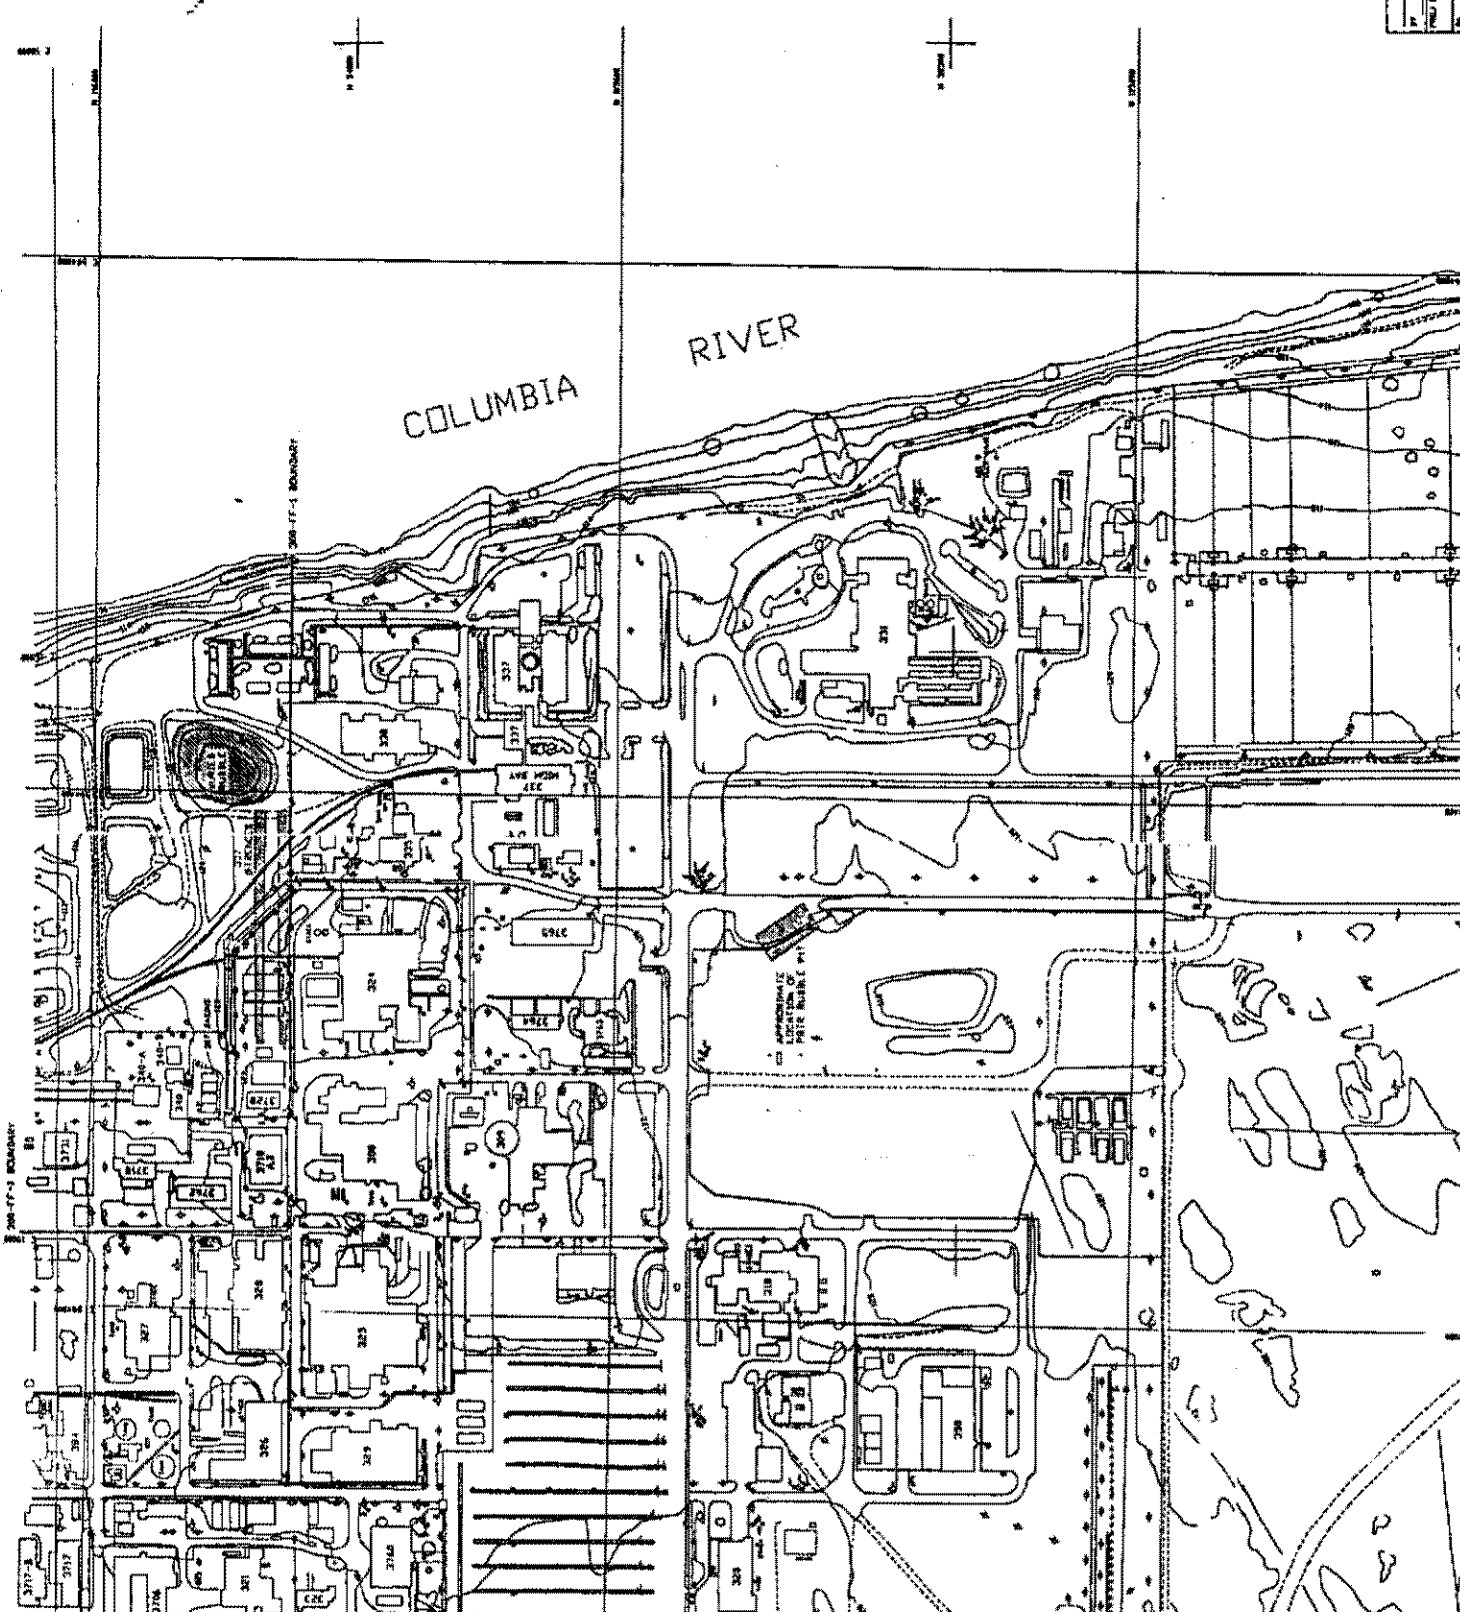
Plate 2
Topographic map of the southern portion of 300-PF-1, showing burial pits and the 307 Trenches.
